Environmental Impact Assessment Report

Appendix B7 Biodiversity

Grangemouth Flood Protection Scheme 2024 Falkirk Council

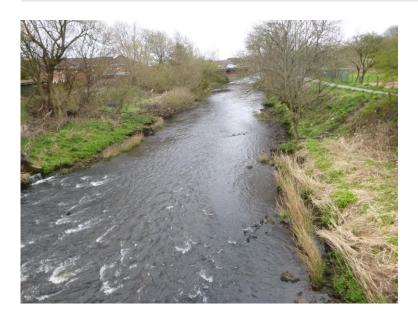
Photograph 2-1: River Carron between the Carron Bridges (NGR NS 88242 82387).

The River Carron is a medium sized river that flows from the Campsie Fells to the Firth of Forth, where it flows out between Skinflats and the Port of Grangemouth. With the exception of the Port of Grangemouth and the village of Carron, the River Carron is bordered primarily by agricultural and woodland/greenspace.

The tidal limit in the River Carron is approximately 300 m upstream of the Carron Bridge at Stenhouse Road (NS 87918 82314). Below this the river is brackish with predominantly soft silt substrates and banks. Above the tidal limit the River Carron is roughly 20-25 m wide with a mix of flow types ranging from shallow riffles to deep glides covering a mixture of aquatic habitats (Photograph 2-1). Substrates throughout the freshwater section were recorded to be mostly cobble and boulder. Overall, the river provides habitat for a range of fish species (e.g. salmonids, European eel, flounder and lamprey) and age classes, but within the Scheme study area, spawning opportunities are limited.

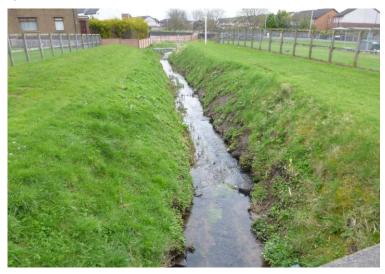
Photograph 2-2: Chapel Burn at Burnside Place (NGR NS 88795 83043).

Chapel Burn is a small watercourse which flows through Stenhousemuir and Carron before joining the River Carron below the tidal limit. The channel has been significantly modified (straightened and deepened) and is generally less than 0.5 m wide with water depths less than 0.2 m (Photograph 2-2). It provides limited habitat for aquatic species.

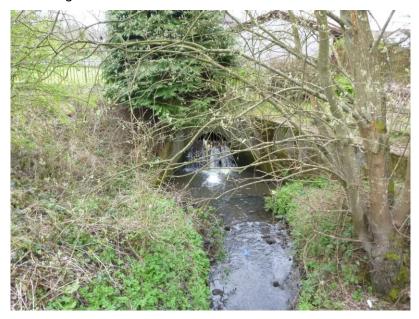
Photograph 2-3: Mungal Burn culvert (NGR NS 88205 82330).

Mungal Burn is a minor watercourse that flows into the River Carron north of Bainsford and just below the tidal limit for the river. This small watercourse is culverted for approximately 800 m beneath residential properties in Bainsford with a debris screen at the outlet which was almost entirely blocked at the time of survey (Photograph 2-3). A short reach of channel, approximately 60 m, is open between the culvert and the River Carron. This section is straightened and approximately 1 m wide with around 0.15 m of water depth. The substrates were a mix of large cobble and pebble which, when combined with the overhanging tree cover, provide a small amount of habitat

suitable for juvenile salmonids, however, water quality appeared poor at the time of survey, being cloudy and containing domestic litter.

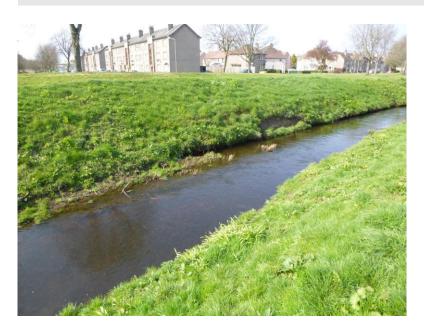
Photograph 2-4: Grange Burn downstream of the M9 (NGR NS 92620 79851).

Grange Burn is a small, heavily modified, watercourse that flows through Rannoch Park, Zetland Park and out into the Firth of Forth between the Port of Grangemouth and the petrochemical plant. Below the tidal limit in Zetland Park (NS 92841 81336), the watercourse is straightened with wooden shuttering along much of the banks and embankments along Grangeburn Road. The channel ranges from around 8 m wide at the downstream end of Grangeburn Road to 3-4 m wide through Zetland Park. The substrates comprise sand and silt with little in the way of flow variation, and although its depth varies with the tide, it is a relatively shallow watercourse with a depth of 0.2 m recorded at the time of survey. Downstream of the rail and pipe bridges associated with the port and petrochemical plant, where it is less constrained, the Grange Burn channel widens significantly and large intertidal mudflats become exposed on both banks. Between the M9 and the tidal limit, the burn is slightly more natural in character, although it is still straightened with sloping grass banks (Photograph 2-4). Substrates comprise pebble and gravel with small amounts of cobble. Overall, the Grange Burn provides a limited amount of habitat for small or juvenile fish, but it does provide clear passage to Westquarter Burn upstream of the M9. The flow control structure on Grange Burn allows water to flow into the flood relief channel under high flow conditions (Photograph 2-5).

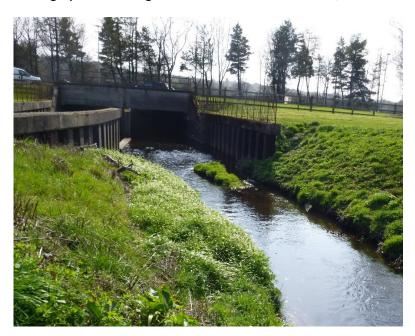
Photograph 2-5: Grange Burn flow control structure (NGR NS 92621 79841).

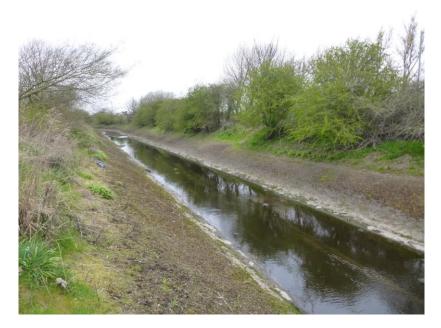
Photograph 2-6: Grange Burn flood relief channel adjacent to Wholeflats Road (NGR NS 93584 79999).

The flood relief channel is a trapezoidal concrete channel which experiences intermittent flows and provides no functional aquatic habitat (Photograph 2-6). Substrates are mostly small (sand, silt and pebble) and the watercourse provides little fish habitat.

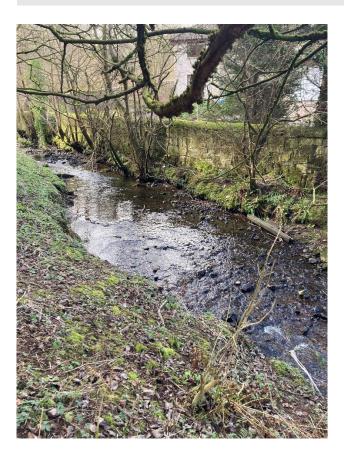
Photograph 2-7: Millhall Burn adjacent to Polmont Woods car park (NGR NS 94054 79472).

Millhall Burn flows into the River Avon, close to outfall from the flood relief channel. The lower reach is narrow, heavily modified, with a gabion mattress covering the substrates and gabion baskets reinforcing the left-hand bank. A large piped culvert discharges the burn into the River Avon. It is unknown whether the culvert presents a barrier to fish migrating upstream into the burn from the River Avon via the flood relief channel. The mid-section near to Polmont Woods, although straightened, retains more natural features with suitable habitat for fish (Photograph 2-7). At this location, mixed juvenile salmonid fish habitat is present, with areas suitable for trout spawning. The gravels are generally clean with pebbles/small cobbles dominating the instream habitat. Occasional pool habitat and tree roots provide parr habitat with the left-hand bank flood defence wall and bridge walls at the water interface providing habitat for eels. Patches of silt could provide habitat for lamprey ammocoetes. Flows are characterised by run/riffle/pool/glide features. The gradient increases from this point upstream to Millhall Reservoir.

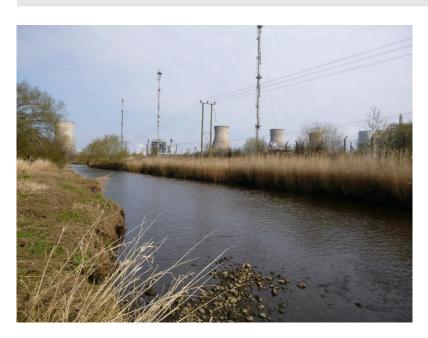
Photograph 2-10: River Avon (NS 94682 80061).

The River Avon flows along the western edge of Linlithgow, under the M9, through the petrochemical plant, and out into the Firth of Forth. The tidal limit on the Avon is on the upstream side of Wholeflats Road (A905) (NS 94647 79723). As with the River Carron and Grange Burn, the substrates consist predominantly of silt throughout the tidal reach, but with a higher proportion of gravel and cobble deposition evident (Photograph 2-10). In contrast to the River Carron and the Grange Burn, the River Avon is relatively unconstrained, with evidence of historic bank reinforcement alongside the petrochemical plant and a section of gabion baskets at the corner adjacent to the flares. In the short, freshwater section within the Site Boundary, substrates form a mix of mostly cobble and boulder, and flows are varied. The river provides habitat for a range of fish species (e.g. salmonids, European eel, flounder and lamprey) and age classes, but within the Site Boundary, spawning opportunities are limited and the habitat is predominantly passage habitat.
