Environmental Impact Assessment Report

Appendix C13 Cultural Heritage

Grangemouth Flood Protection Scheme 2024 Falkirk Council

Appendix C13.1 Desk Based Survey

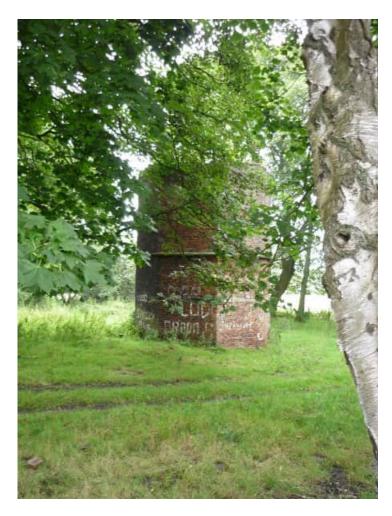
Photograph 13.1 - Dovecot, Carron House (Asset 11)

Dovecot, Carron House (Asset 11) is an octagonal Georgian structure that dates to the late 18th century and is associated with Carron House (Asset 15). It is brick built with freestone dressings and contains 1016 nests. Its setting gives a positive contribution to its significance as its location within the wider grounds of Carron House in quiet rural countryside. It does have graffiti on its base (see Photograph 13.1). In consideration of its historic interest as a Georgian Dovecot, as a good example of its type and its Listed status Asset 11 has been assessed to be of medium value.

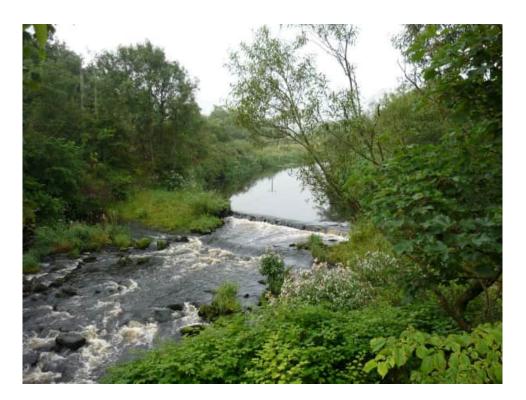
Photograph 13.2 - Weir Carron Iron Works (Asset 18)

Weir Carron Iron Works (Asset 18) is thought to date to 1749. It is a gravity weir across the River Carron (Photograph 13.2) and has a bullnosed ashlar shallow-sloped face on the downstream side, its central section was removed to allow salmon up river destroying its structural integrity. In consideration of its historic interest as one of a few surviving remnants of Scotland's first major smelting works and its Listed status Asset 17 has been assessed to be of medium value.

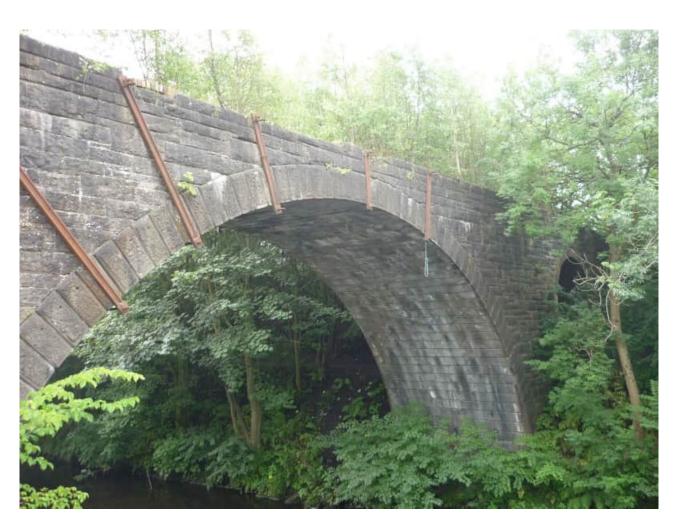
Photograph 13.3 - Former Railway Bridge Across River Carron Iron Works (Asset 19)

The Former Railway Bridge Across River Carron Iron Works (Asset 19; Photograph 13.3) is thought to date to 1860 and comprises a 2-span segmental arched masonry bridge. It has channelled bullnosed ashlar voussoirs with dressed margins and snecked rubble spandrels. Its setting gives a positive contribution to its significance with its location over the River unaltered and its association with surviving elements of Carron Iron Works. It is one of the few substantial survivors from the Carron Iron Works, Scotland's first major iron smelting works, in consideration of this and its Listed status it has been assessed to be of medium value.

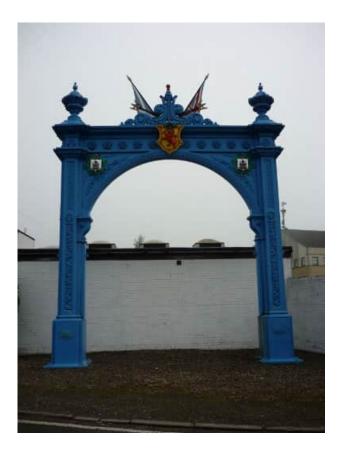
Photograph 13.4 - Grahamstown Cast-Iron Gate (Asset 20)

The Grahamston Cast-Iron Gate (Asset 20; Photograph 13.4) dates to 1886 and was made by the Grahamston Iron Company in Falkirk for the Edinburgh International Festival Exhibition of the same year at which it won a Diploma of Honour. It weighs 20 tons and is amongst the largest cast iron arches in the United Kingdom. It was refurbished in 2002 and relocated a kilometre or so to the north of its original location. Its setting gives a neutral contribution to its significance due to its relocation. In consideration of its historic interest as one of the largest cast iron arches in the United Kingdom and its Listed status Asset 20 has been assessed to be of medium value.

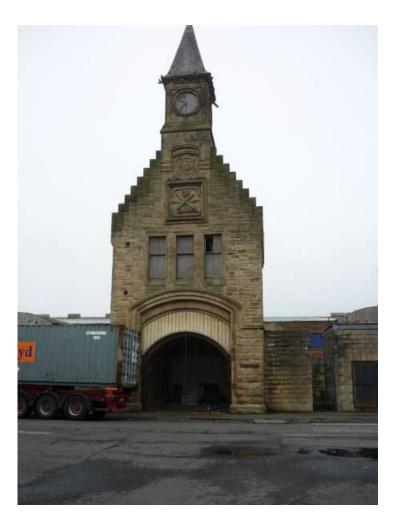
Photograph 13.5 - Carron Company, Clock Tower Remnant of Former Office Block (Asset 16)

Carron Company, Clock Tower Remnant of Former Office Block (Asset 16; Photograph 13.5), a Category C Listed Building, was constructed between 1874 and 1875 and is attributed to Robert Baldie. It comprises a crow-step gabled, clock tower remnant of the Stirling-School Baronial style offices of the Carron Company Ironworks that was retained when the rest of the building was demolished in 1990. Its setting gives a positive contribution to its significance with its location unaltered and its association with surviving elements of Carron Iron Works. In consideration of its historic interest as an interesting local landmark and as an example of the Stirling-School Baronial style and its Listed status this historic clock tower has been assessed to be of low value.

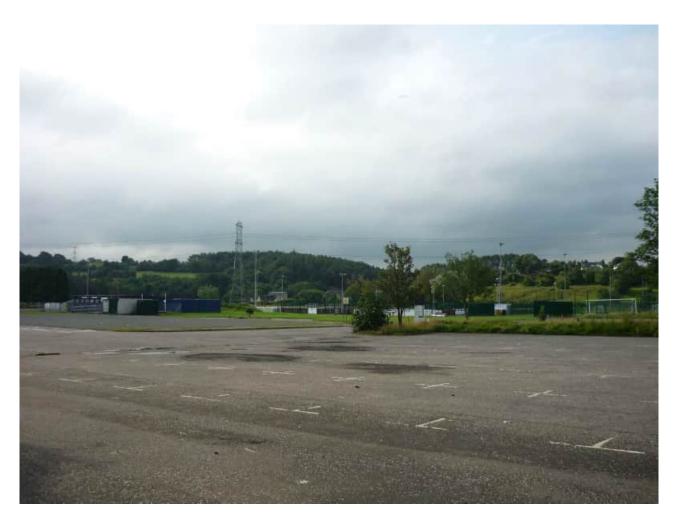
The Antonine Wall WHS (Asset 1; Photograph 13.6) comprises the most northerly frontier of the Roman Empire that was constructed approximately 2,000 years ago. 40 Roman miles in length (60km) it runs between Bo'ness on the Firth of Forth and Old Kilpatrick on the River Clyde. When constructed it was the most complex frontier ever created by the Roman army. It was built on the orders of the Emperor Antoninus Pius around 140AD and was both a barrier and a physical manifestation of the power and control of the Roman Empire. Forts and fortlets along the wall acted as secure crossing points controlling movement to the north and south as well as housing the frontier troops. In consideration of its potential contribution to research agendas questioning the issues of identity and social space on the frontier and on the purpose and function of frontiers (ScARF, 2012a) and its WHS status Asset 1 has been assessed to be of very high value.

Photograph 13.6 - Antonine Wall WHS (Asset 1) visible as the high ground to the centre of the photograph

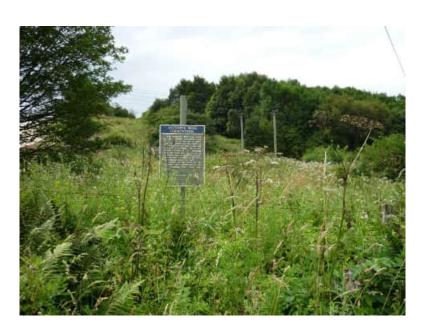
The Antonine Wall, Millhall Burn to River Avon (Asset 7; Photograph 13.11) comprises a section of the Antonine Wall that runs from Millhall Burn in the west through Polmont Woods, Grangemouth Golf Course and past the Polmont dry ski slope to the River Avon in the east. This section of the wall is unusual because it has the remains of at least three temporary camps in close proximity. In consideration of this and its potential contribution to research agendas questioning the issues of identity and social space on the frontier and on the purpose and function of frontiers (ScARF, 2012a) and its Scheduled status, this cultural heritage asset has been assessed to be of very high value.

Photograph 13.11 - The Antonine Wall, Millhall Burn to River Avon (Asset 7) the line of the ditch can be seen to the left of the sign

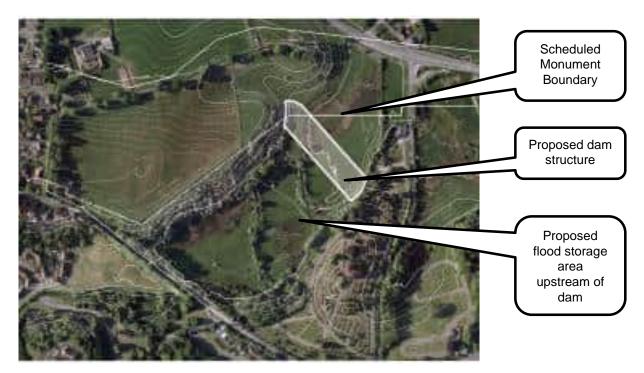
Figure 6: Option 1

There has been extensive design development and consultation undertaken regarding the Flood Storage Area at Westquarter Burn. The initial proposal is shown in **Figure 6**. The proposal was for an 8m high dam structure incorporating a flow control structure such as a hydrobrake. The dam would retain floodwaters against the existing valley slopes.

This option involved part of the dam structure being constructed within the Mumrills Fort (scheduled monument), and within the setting of the World Heritage Site – close to the line of the wall itself. The proposal was shared with HES.

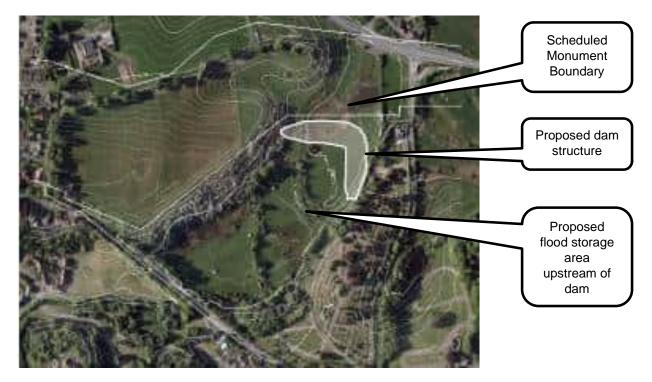
Figure 7: Option 2

In response, a second option was developed. This altered the geometry of the dam structure to avoid encroachment of the scheduled monument, however, it did not address the adverse effect on the WHS OUV and its setting nor of the issue of the proximity to the WHS this is shown in **Figure 7**.

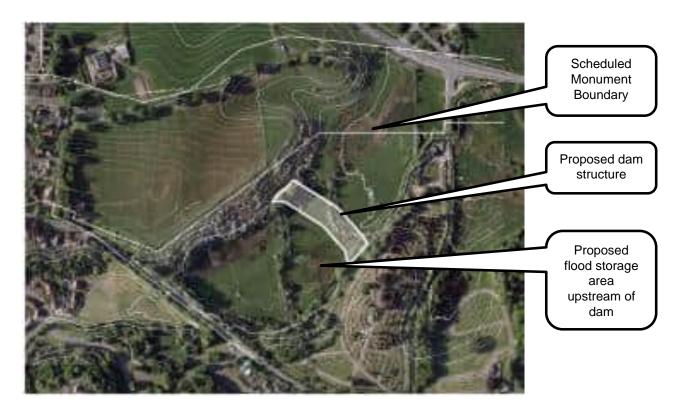
Figure 9: Option 3

Figure 9 Option 3 has a smaller, 6m high, structure, located further away from the line of the Antonine Wall.

Whilst the fact that the location of the proposed structure was now further away from the line of the wall was welcomed, HES still had concerns regarding the impact on the OUV due to the loss of the Carse valley and the disruption of the relationship between the high ground and the valley floor when viewed from the bluff. It was agreed that Jacobs would continue their interrogation of this relationship and refine the proposals to further mitigate potential impacts.

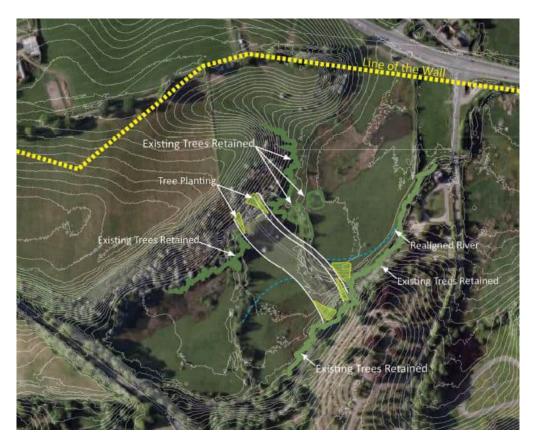
Figure 10: Option 4

Figure 9 Option 3 had been further developed to create a sinuous shape and to integrate the structure with the adjoining landform and vegetation.

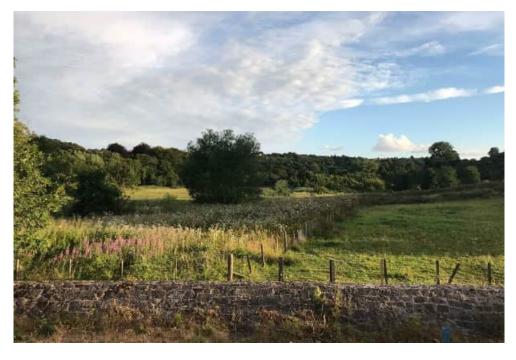
A series of photomontages for a range of viewpoints were also presented showing the current proposals with a range of finishes and varying extents of screening planting.

Figure 11: Option 4 summer photomontage

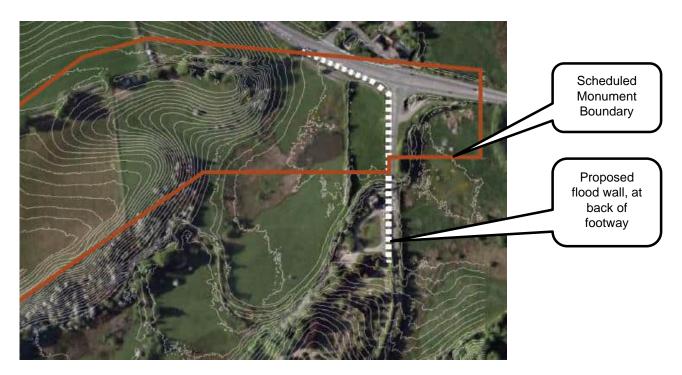
Figure 12: Option 4ai

This flood wall would need to be up to 1.8m high (above existing ground level), with the majority of the wall approximately 1m high.

The wall could have a much-reduced impact on the WHS' OUV as it would form part of the modern infrastructure of the road and wouldn't bisect the valley as the previous options had. It would also have less visual impact.

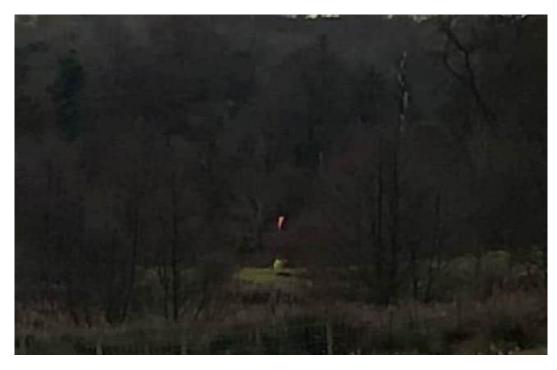
The position of the dam and wall was set out on site with individual masts with high vis flags being held in the appropriate positions, so that attendees could envisage the dam impacts.

Figure 15: Masts with hi-vis flags showing the height of the dam structure

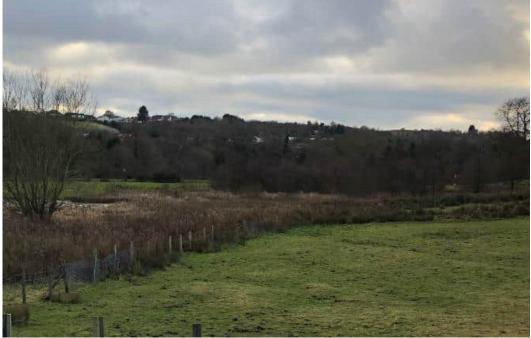
Figure 16:Masts with hi-vis flags showing dam structure
